1234 School House Road
Yourtown, US 12345

Summary

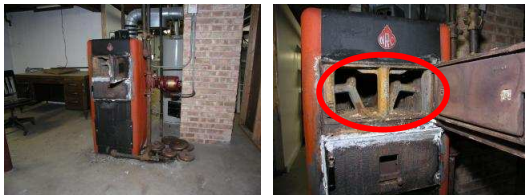
34. Basement Heating System Heating System Operation: Recommend replacement **Boiler system is antiquated and lacks safety features found on newer units including non-sealing combustion chamber which can cause health issues**

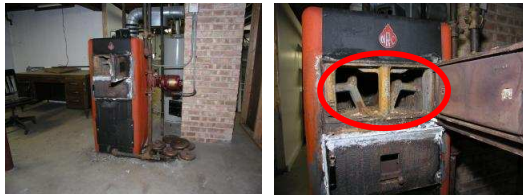
1. Marginal Heating System Operation: Recommend replacement Boiler system is antiquated and lacks safety features found on newer units including non-sealing combustion chamber which can cause health issues
